METALLOSIS OF THE RESURFACED HIP

James W. Pritchett MD

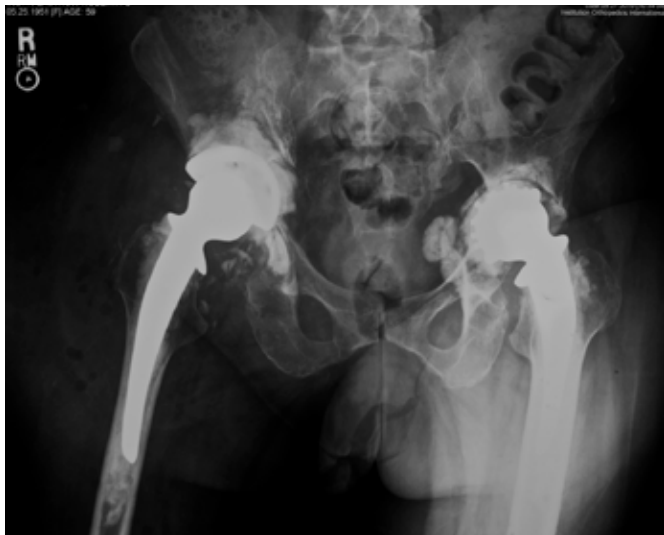
Fig. 1 This anteroposterior pelvis radiograph shows a 58 year-old woman 40 years after receiving bilateral McKee-Farrar total hip replacements. On the left the original metal-on-metal prosthesis demonstrates acetabular loosening. On the right a revision using a custom made two-piece titanium and polyethylene acetabular prosthesis has been performed.

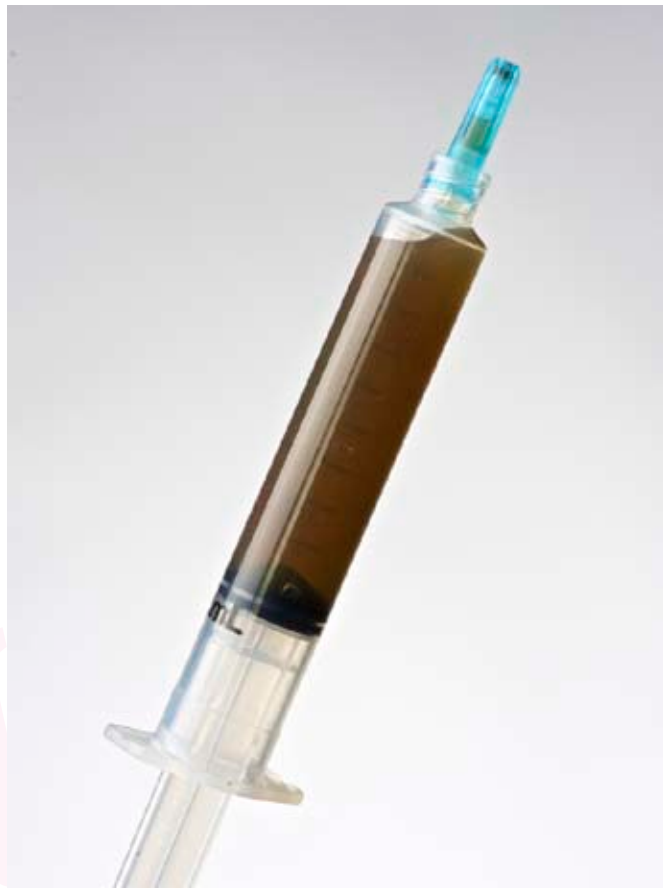
Fig. 2 This syringe shows joint fluid that has been aspirated from a patient with metallosis 2 years following hip resurfacing surgery.

erally $< 9 \mu\text{g/L}$. Cobalt levels $> 100 \mu\text{g/L}$ are found occasionally. Patients with equivocal levels should be followed over time with repeated testing. If the cobalt level is increasing, metallosis should be suspected. In some laboratories, testing of the joint fluid is possible but usually the appearance of the aspirated fluid is information enough to diagnosis metallosis (Fig 2).

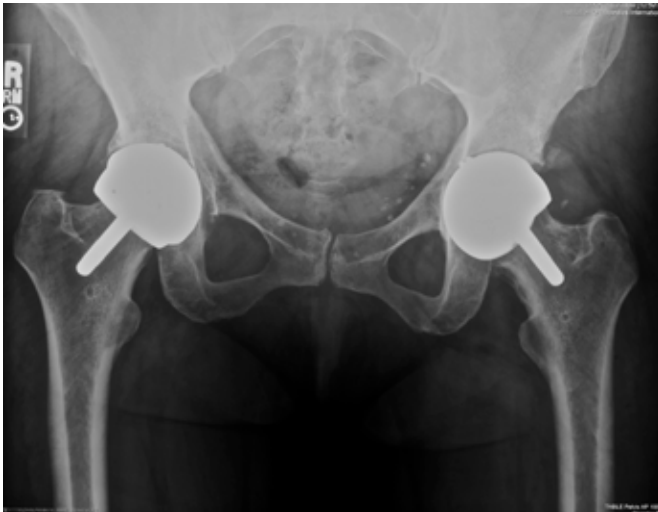
Fig. 3 This anteroposterior radiograph shows a 46 year-old woman who has undergone bilateral hip resurfacing surgery using Birmingham prostheses. On the right the outcome is successful but on the left the hip is painful from failure of osteointegration and there is a lucent line around the acetabular prosthesis.

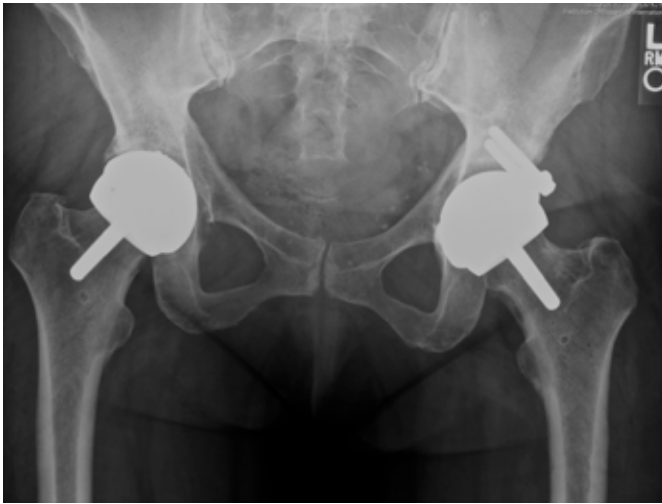
Fig. 4 A revision of the left acetabular component has been performed using a dysplasia component with supplemental screw fixation.

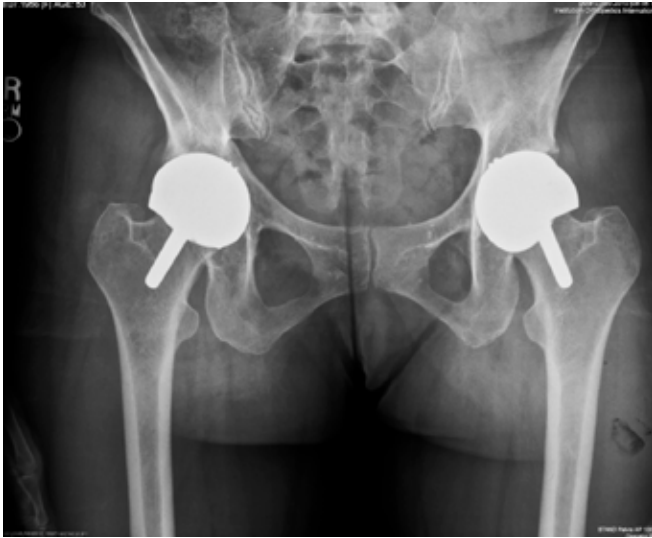
Fig. 5 This anteroposterior radiograph shows a 45 year-old women who underwent bilateral hip resurfacing surgery for dysplasia. On the right the outcome was successful but on the left she developed metallosis and the acetabular component has a vertical orientation.

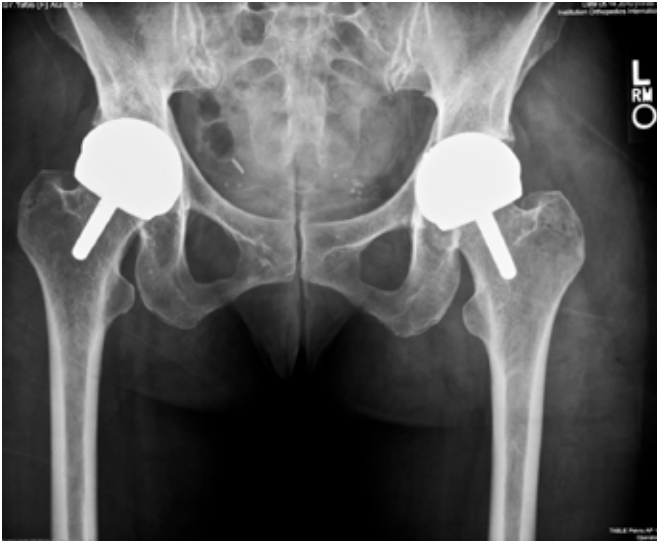
Fig. 6 A revision of the left acetabular component to a more horizontal position has been performed and the outcome is successful.

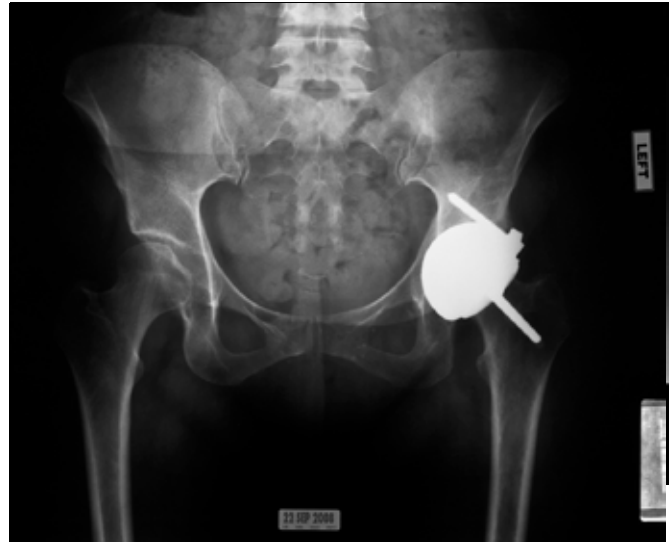
Fig. 7 This anteroposterior radiograph shows the Conserve Plus dysplasia prosthesis that has been successfully used for revision surgery in this 44 year-old woman.

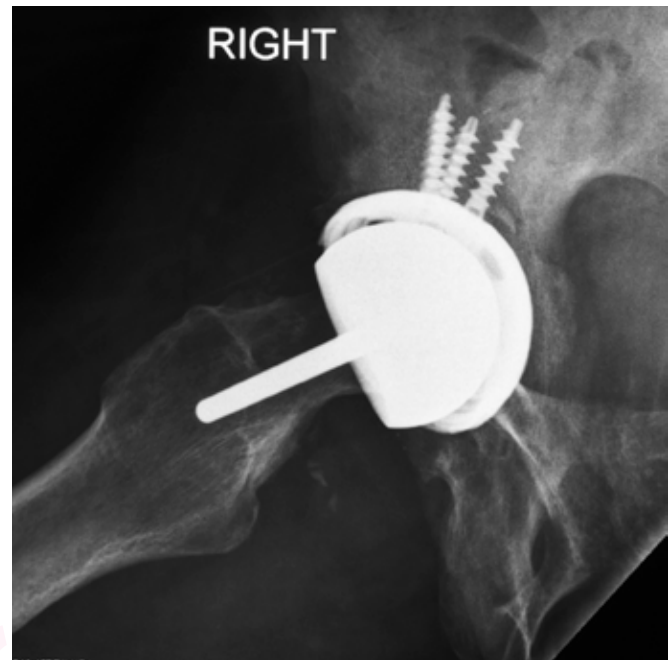
Fig. 9 The lateral radiograph shows the availability of dome screw adjunctive fixation in the compromised acetabular bone.

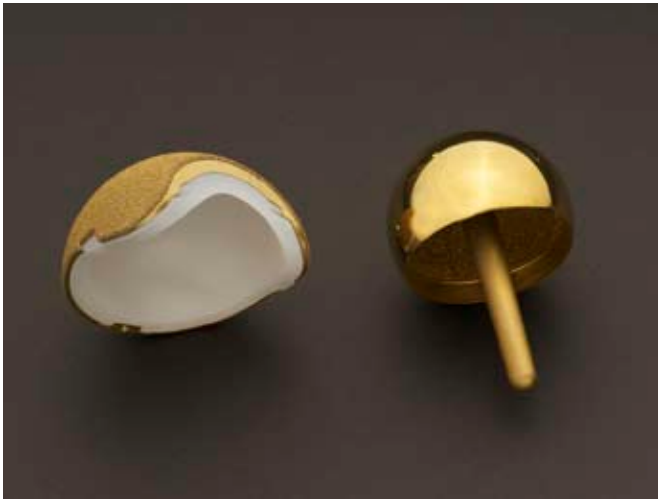
Fig. 10 This photograph shows a currently available resurfacing prosthesis with a titanium backed polyethylene acetabular bearing surface as an alternative to metal-on-metal.
